# DESIGN CONCEPT PROPOSAL

December 21, 2021  
Gatherings, 1024 6<sup>th</sup> St, Nevada, IA  
Project #11021

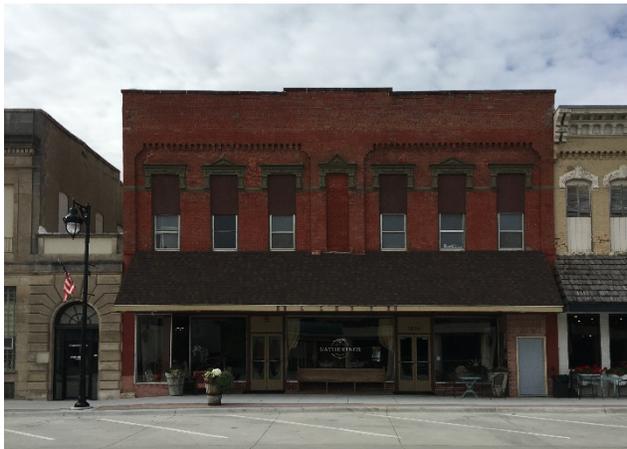
*Existing Building*

- Clean masonry façade as needed using gentlest means possible (do not sandblast!). There appear to be areas of missing mortar and previous patching at the upper façade – repoint and repair as needed using a mason well versed in historic masonry (refer to Preservation Briefs [1](#) and [2](#) for additional guidance).

- Remove the shingle sheathed awning from the storefront. Assess materials and structure underneath and make any repairs needed. It is assumed the historic transom windows and storefront cornice details have been removed, but if they are intact once the awning is removed, they should be retained and repaired if possible. Consult with MSI at that time for updated recommendations.

- Remove infill panels and replacement units from the upper story windows. Insert new window units that fill the full size of the opening and are compatible with the one over one windows shown in the historic photograph. The center window opening has been bricked in over time; it is not shown restored in the concept drawing but could be reopened if the upper story floor plan allows.

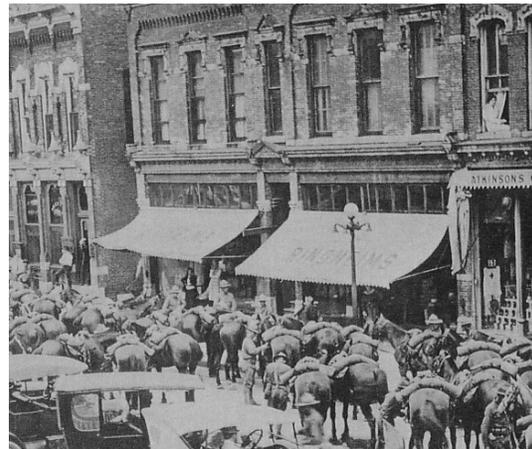
*Historic Photograph*

- While the building originally had an elaborate, large-scale cornice on the upper façade (seen from a distance at right), restoring that configuration is likely not feasible and would need to follow documentary evidence. A smaller scale simplified cornice band is shown here that corresponds with the storefront.

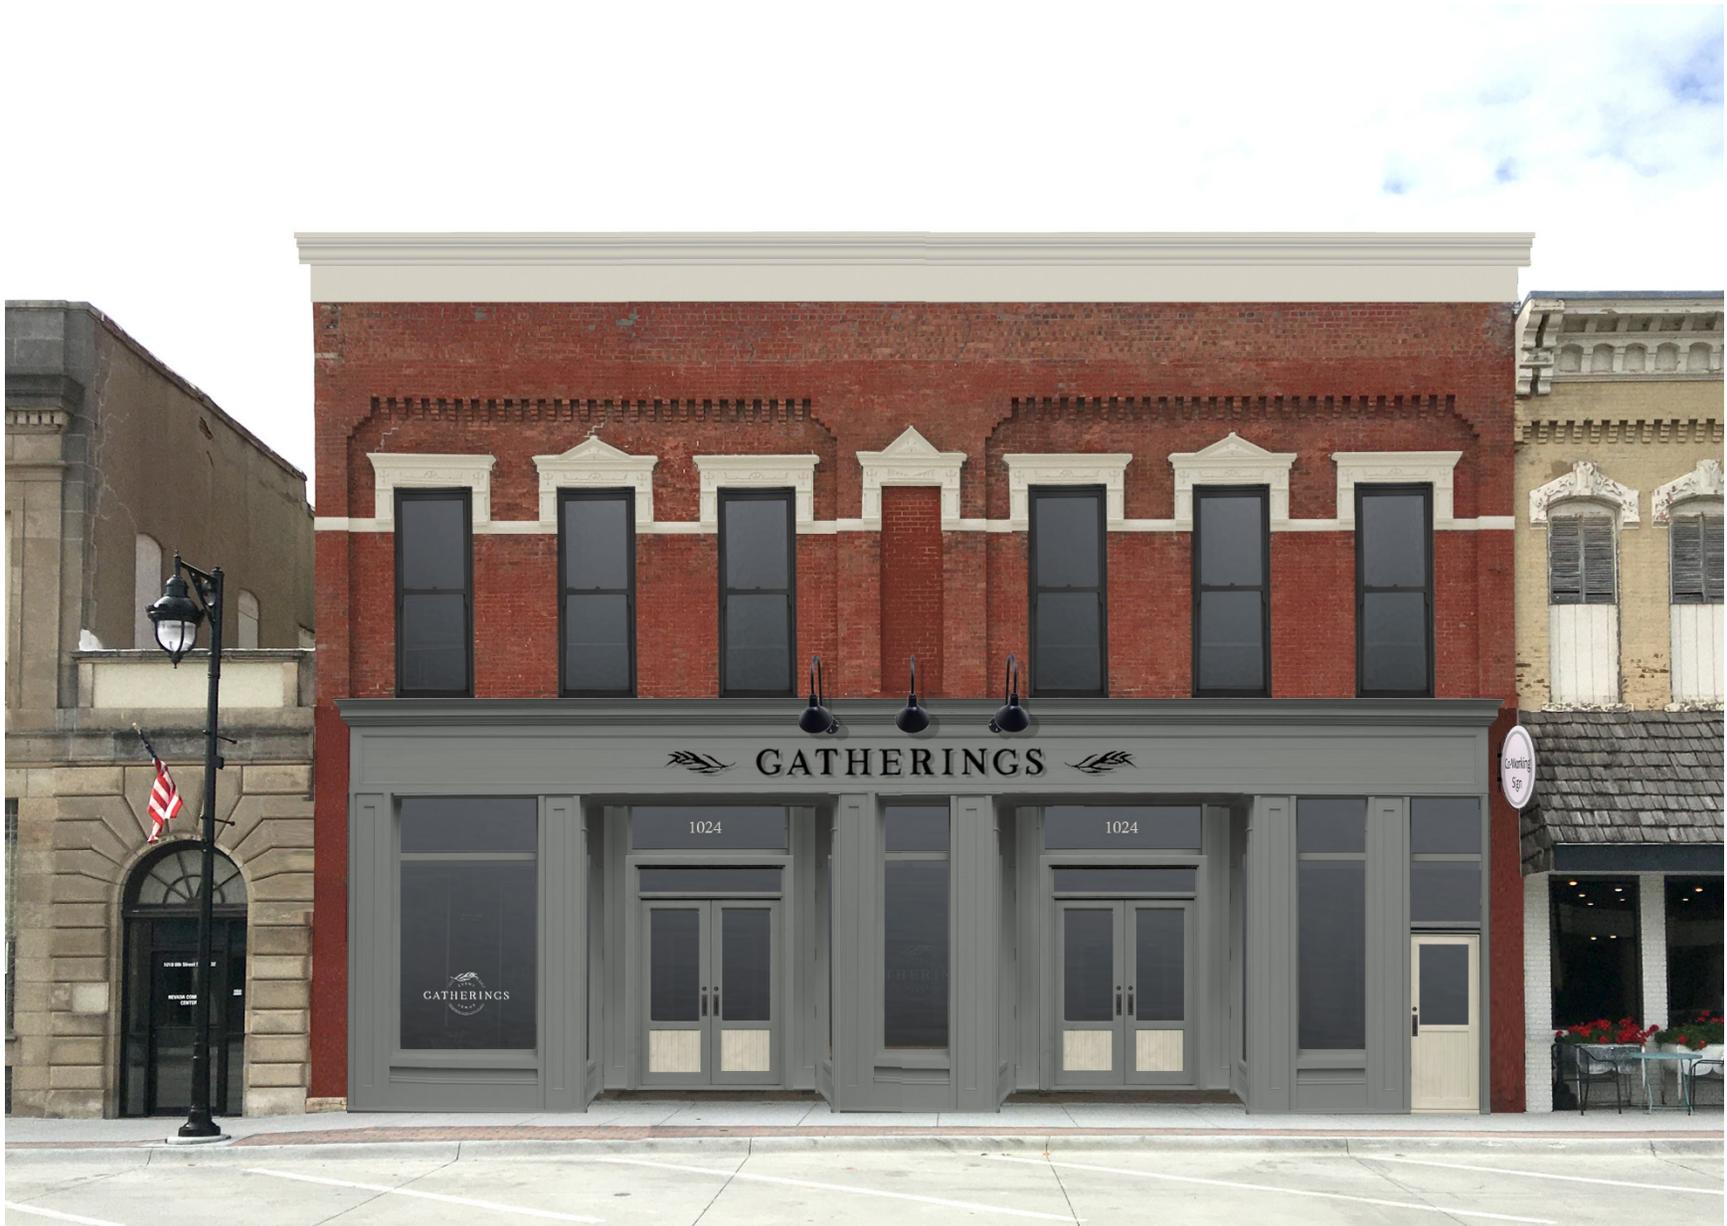
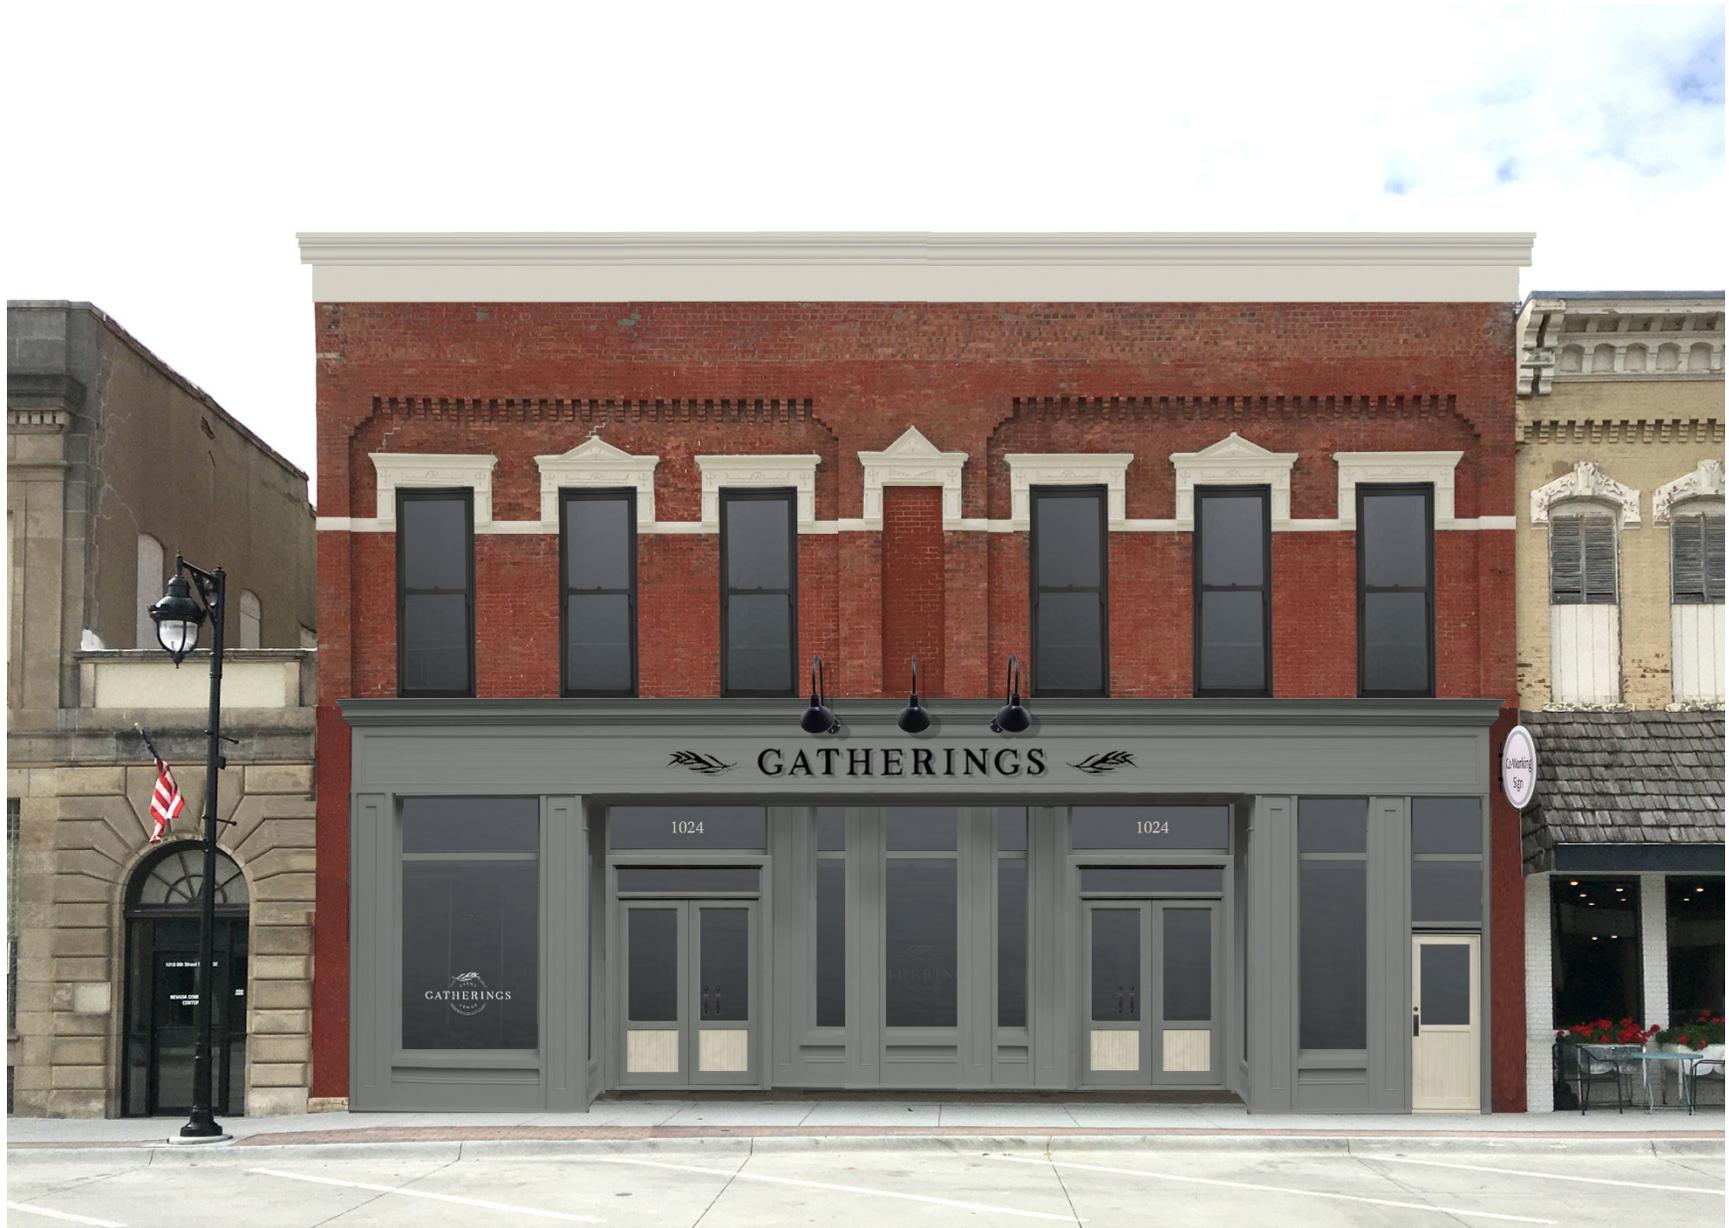
- Install a new storefront system that is compatible with the scale, proportion and historic elements of the building. Include large display windows with clear insulated glass, transom windows above and bulkhead panels below. Use trim and panel details to give the storefront a quality millwork appearance. Two storefront

configurations are shown here: one similar to the existing configuration that is largely recessed, and one with a more traditional configuration with each doorway recessed. It's recommended to retain both doors for scale, function during events, and future building uses.

- This drawing proposes a façade rehabilitation concept for the Gatherings building at 1024 6<sup>th</sup> Street.
- The building has seen numerous alterations since its 1885 construction but is still listed as a Contributing building in the Nevada Downtown Historic District. Significant changes include combination of the first floor into a single storefront, relocation of the upper story access door from the center of the building, reduction of the upper story window openings, removal of the ornate cornice on the upper façade, and addition of the shingle sheathed awning (and presumed removal of the historic ornamental details underneath). Full restoration of the historic façade likely isn't feasible or recommended due to the extent of these alterations, but improvements are shown that are compatible with the building's overall character and current use.

- Paint the storefront system, window hoods, and cornice. An example color scheme is included below.
- Add business signage to the façade. Individually mounted letters are shown on the storefront cornice/sign band for Gatherings, with gooseneck lighting above for added evening illumination and visibility. A smaller scale projecting sign is shown near the upper story entry door to identify the upper floor coworking space.
